A QUARTERLY PUBLICATION
BOEING.COM/COMMERCIAL/
AEROMAGAZINE

AERO

Engine Fuel Filter Contamination

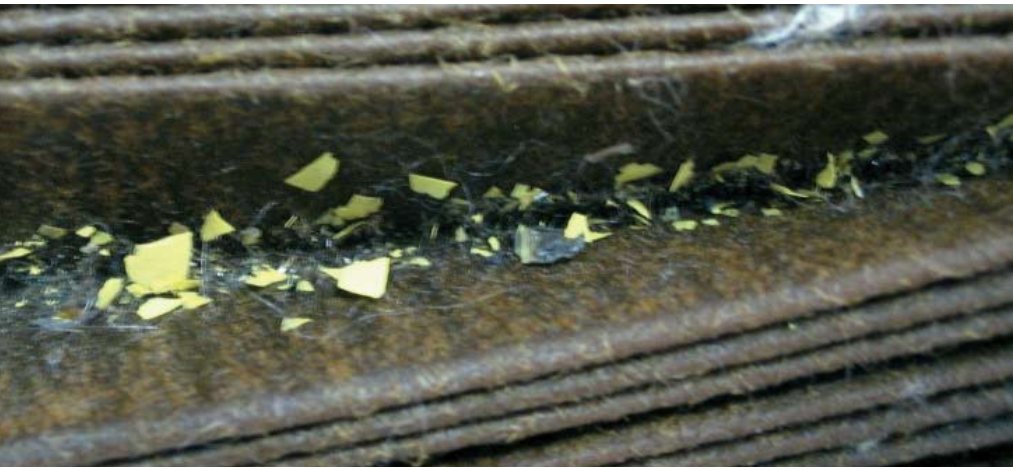
Figure 1

problem. The majority of the fuel filters examined were filled with silicates (i.e., dirt), sulfates, iron oxide (i.e., rust), and salts (see fig.1). The team could not draw a specific conclusion but suspected that the contamination was being uplifted with the fuel. The team also suspected that the fuel technically would pass the ATA 103 fuel handling specification for cleanliness.

CONTAMINATION TRAPPED BY A FUEL FILTER

A visual inspection of a fuel filter reveals a variety of contaminants.

It's important that airlines work with their fuel suppliers to ensure that local fuel handling procedures are being followed. If the source of the contamination cannot be found, the only alternative is to replace the fuel filters more frequently.

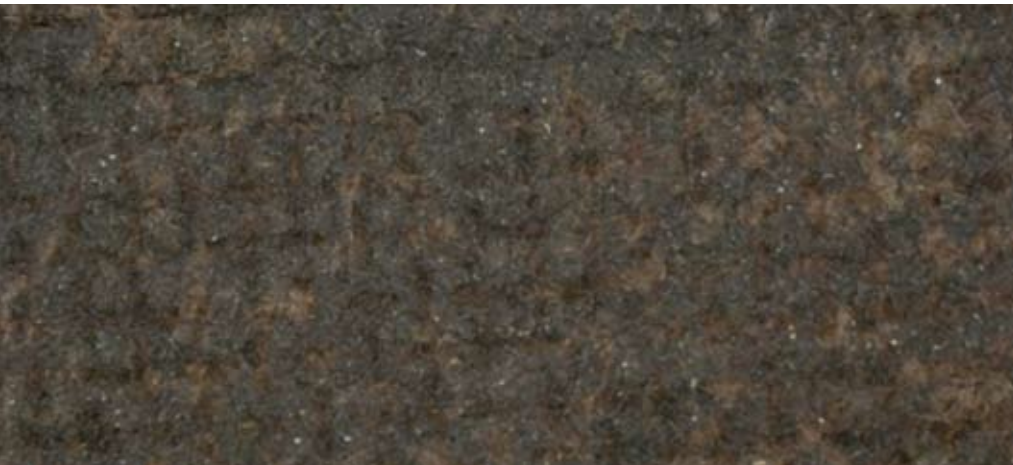
Figure 2

CONTAMINATED FUEL FILTER CAUSES LOSS OF POROSITY

The individual particulates found on fuel filters are very small, often less than 1 micron in size. However, these particulates become bound together on the filter medium and filter screen.

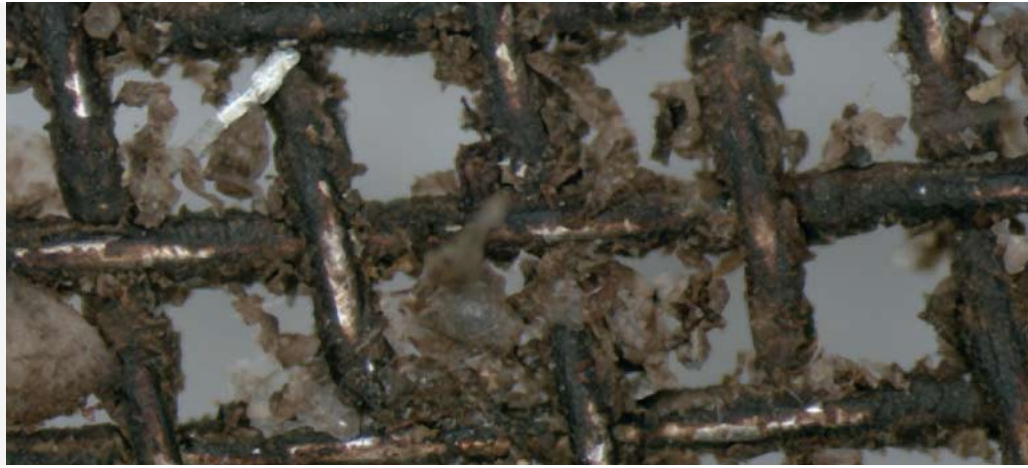
Figure 3

This filter screen is contaminated with particulates and a gum residue.

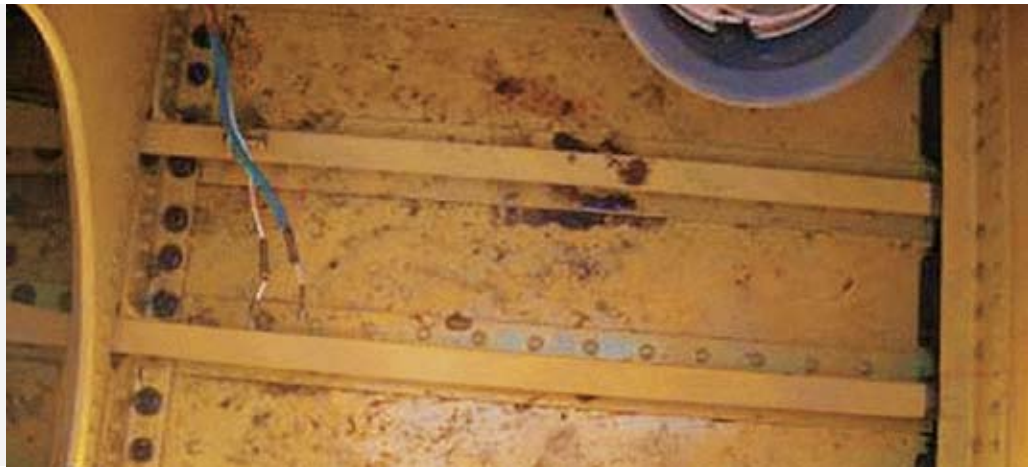
Figure 4

MICROBIAL CONTAMINATION IN A WING TANK

The brown-black debris on the bottom of this tank is made up of fungus and bacteria. Fuel microbial growth can clog fuel filters, causing the airplane fuel quantity indication system to read incorrect values, and eventually cause structural corrosion of the aluminum stringers and wing skin. Operators can greatly reduce the chance of microbial growth by draining water from airplane fuel tanks weekly and by testing for microbes annually.
